US ARMY  
TEST & EVALUATION COMMAND

FINAL REPORT OF TEST  
MILITARY POTENTIAL TEST  
OF THE  
HELICOPTER ROTOR BLADE EROSION-PREVENTIVE KITS  
DA PROJECT NO. 1R179191-D-684  
USATECOM PROJECT NO. 4-3-5220-02 ✓

FINAL REPORT OF TEST

HELICOPTER ROTOR BLADE EROSION-PREVENTIVE KITS

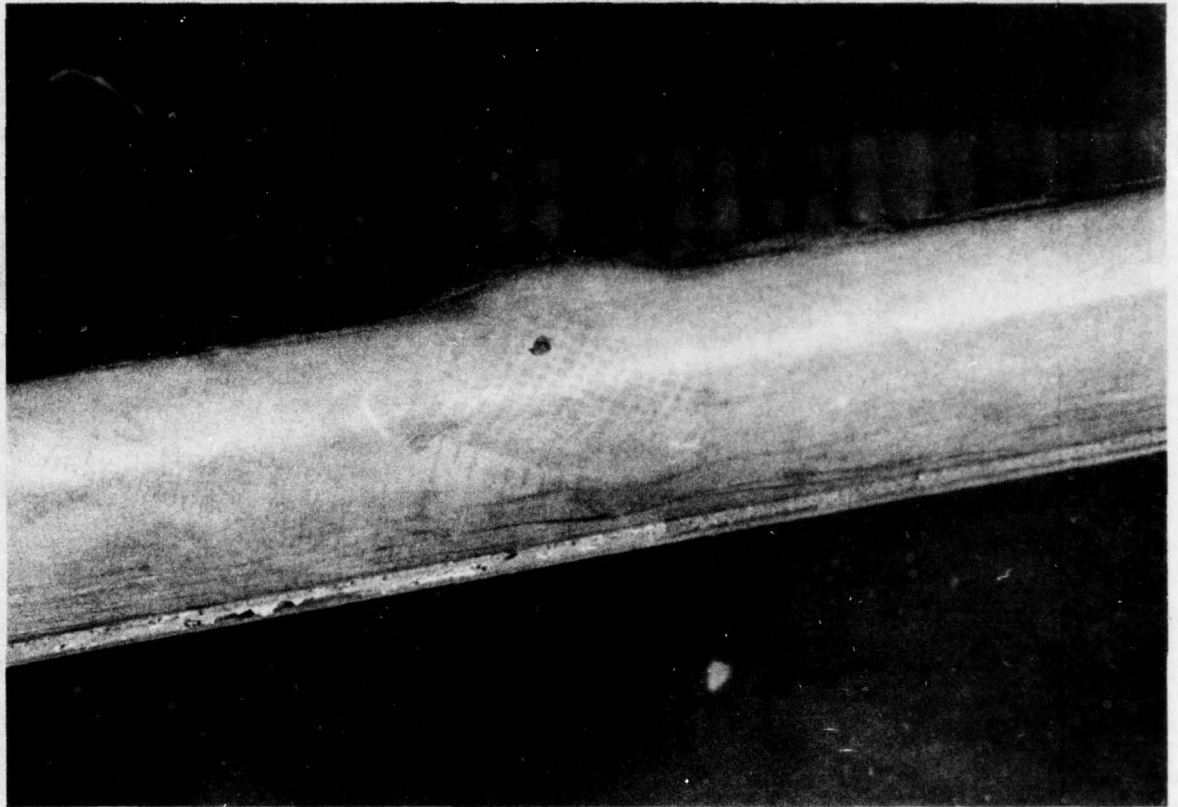
2.3.3.2. Application of the Polyurethane shoes (accomplished before the blades are installed on the helicopter) required that the rotor blades be balanced before installation on the helicopter and that they be tracked prior to flight. Application of the Estane and Neoprene shoes (accomplished while the blades are on the helicopter) required blade tracking prior to flight. Improper application resulted in vibrations and unsatisfactory flight characteristics (figure 1).

Figure 1. Improperly applied Neoprene shoe after flight

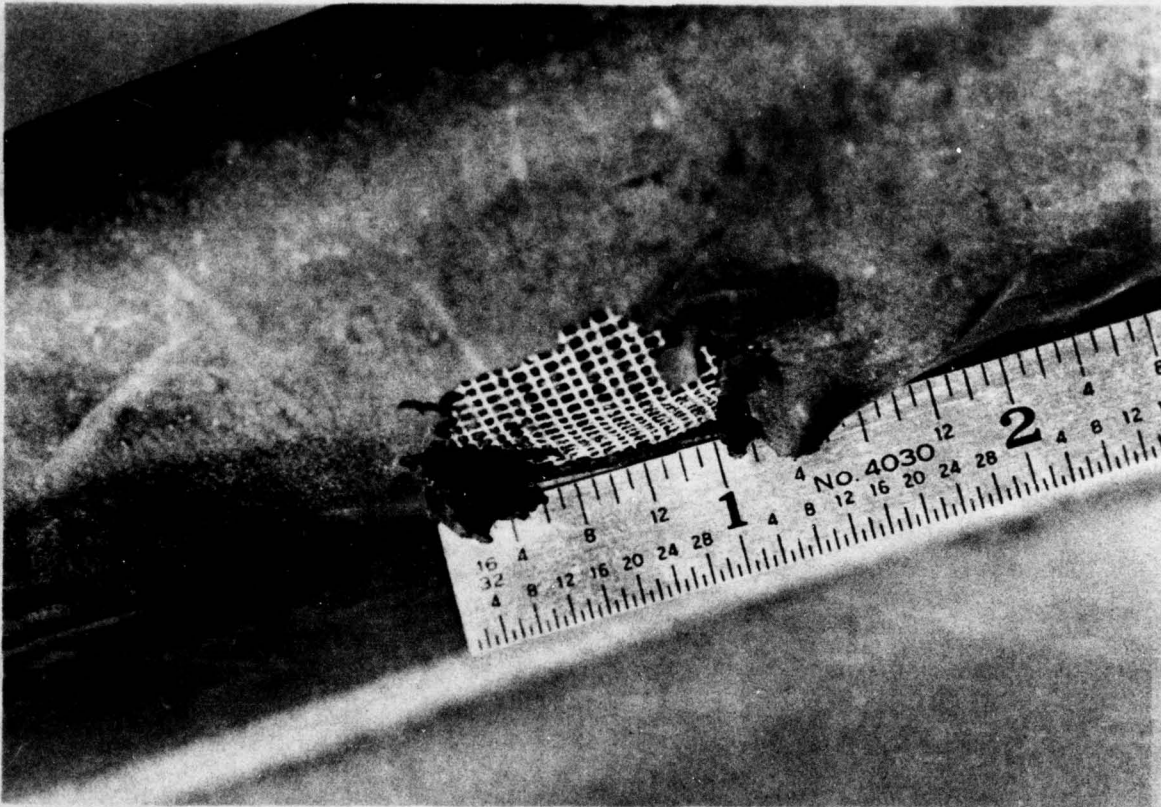
2.3.3.4. Damage such as bubbles and small separations caused moderate vibrations. Extensive damage such as loss of portions of the shoe caused severe vibrations (figure 2).

Figure 2. Estane shoe damage resulting from flight in rain.

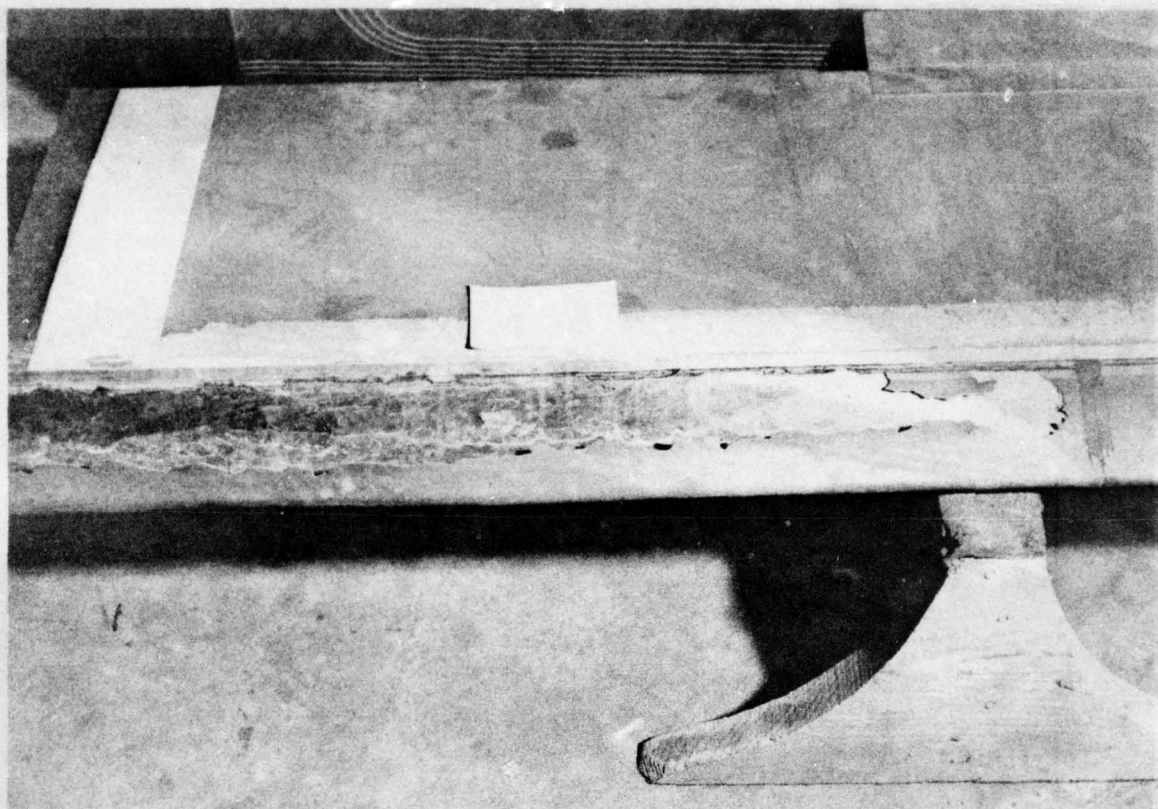
Figure 3. Polyurethane shoe damaged by flight in heavy rain.

Flight through rain was detrimental to Polyurethane, Estane, and Neoprene shoes. Flight through light rain resulted in reparable damage such as bubbles in the surface of the shoes and minor separation of the trailing edges. Flight through moderate rain for short periods of time (5 to 15 minutes) resulted in reparable damage such as bubbles in the surface of the shoes and trailing edge separation. Flight through moderate rain for prolonged periods (one to three hours) caused irreparable damage to the shoes. Flight through heavy rain destroyed the shoes. The maximum flying time accumulated in heavy rain prior to destruction of the shoes was three hours.

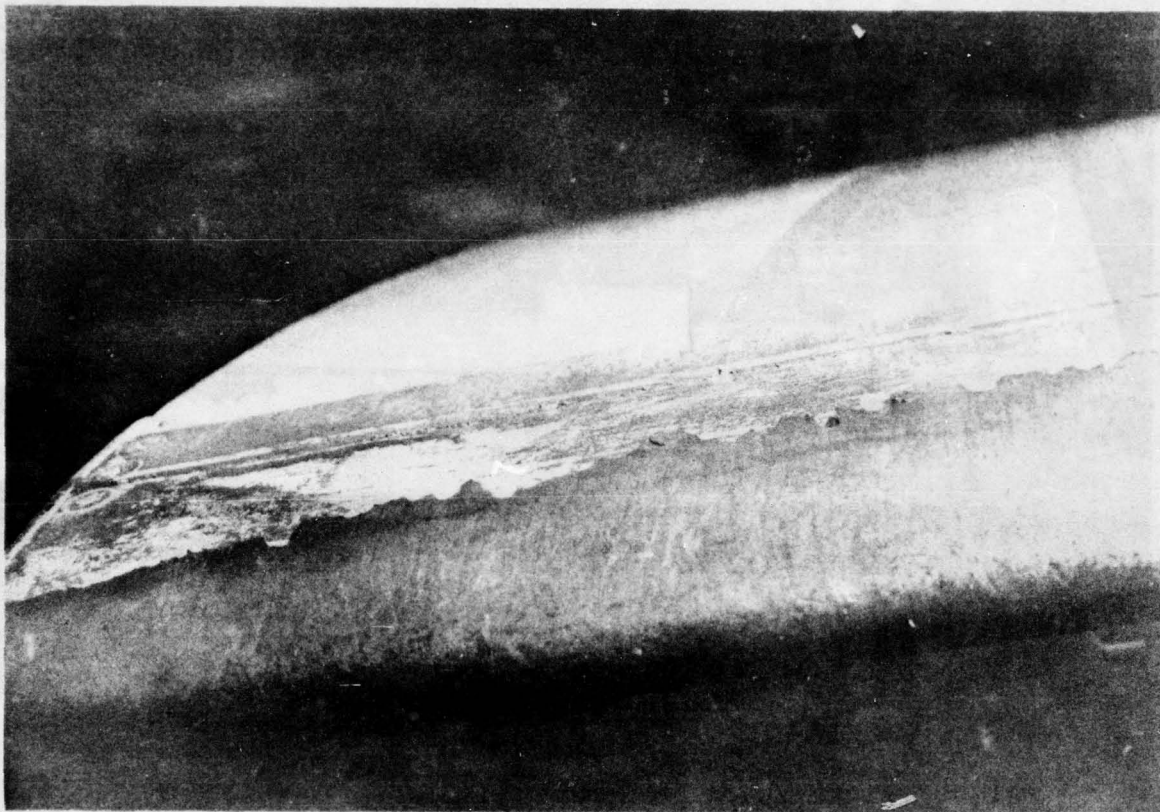
Figure 4. Neoprene shoe damaged by flight in heavy rain.

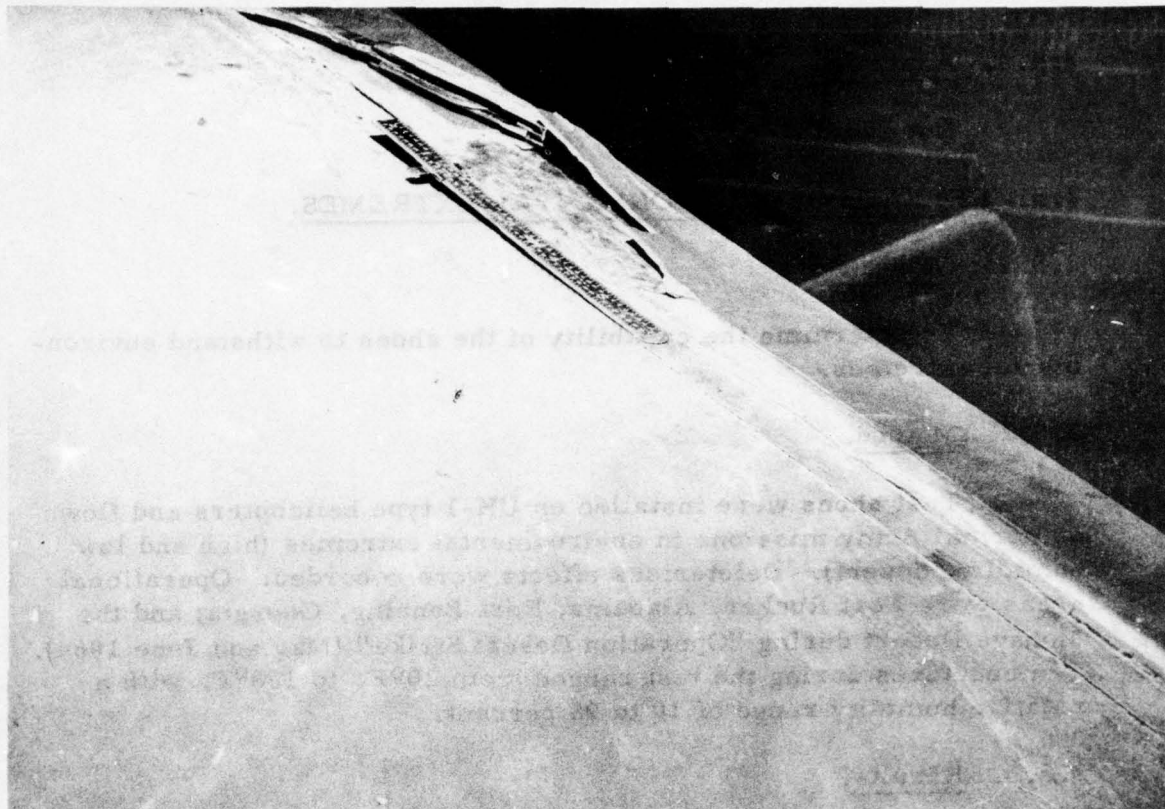
Figure 5. Polyurethane shoe with separation caused by flight in rain.

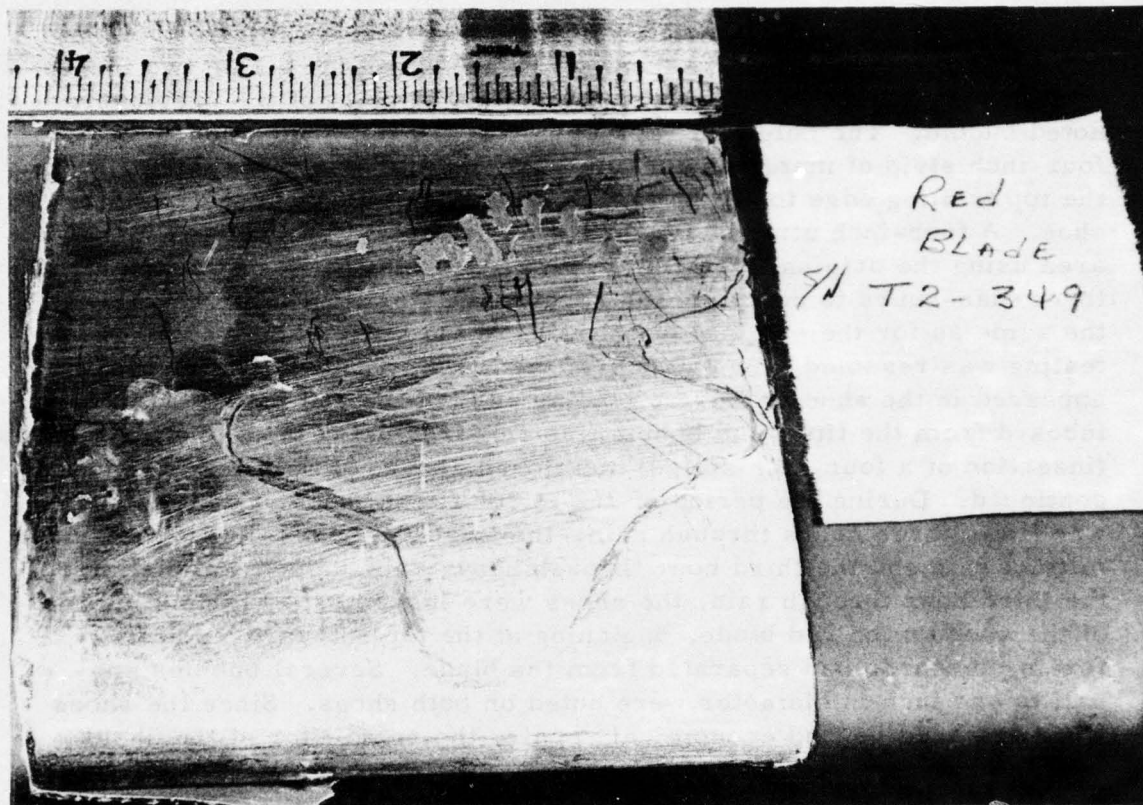
Figure 6. Polyurethane shoe with damaged portion removed to effect repair.

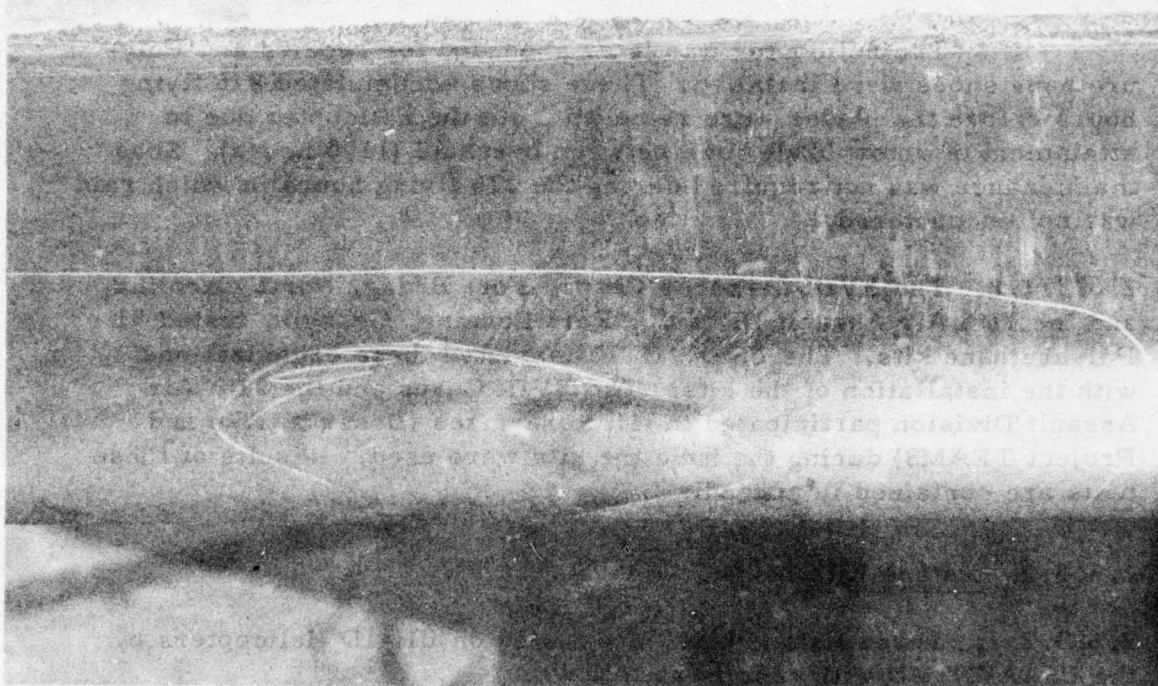
Figure 7. Estane shoe showing bubble.

last three hours were in heavy rain, three bubbles appeared in each shoe. The bubbles were 1 1/2 inches in diameter and located on the top leading edge of the inboard three feet of the shoes. Inspection revealed that water had been forced under the shoes through small nicks in the surface of the material. Since erosion was usually more severe on the outboard three feet of the blade, the inboard three feet of each shoe were removed and the helicopter released for flight. Removal of the inboard three feet of the shoes required two mechanics three man-hours. The first flight after removal of the inboard three feet was of one hour's duration in heavy rain. Upon completion of the flight, the shoes were found to be unserviceable and were removed.

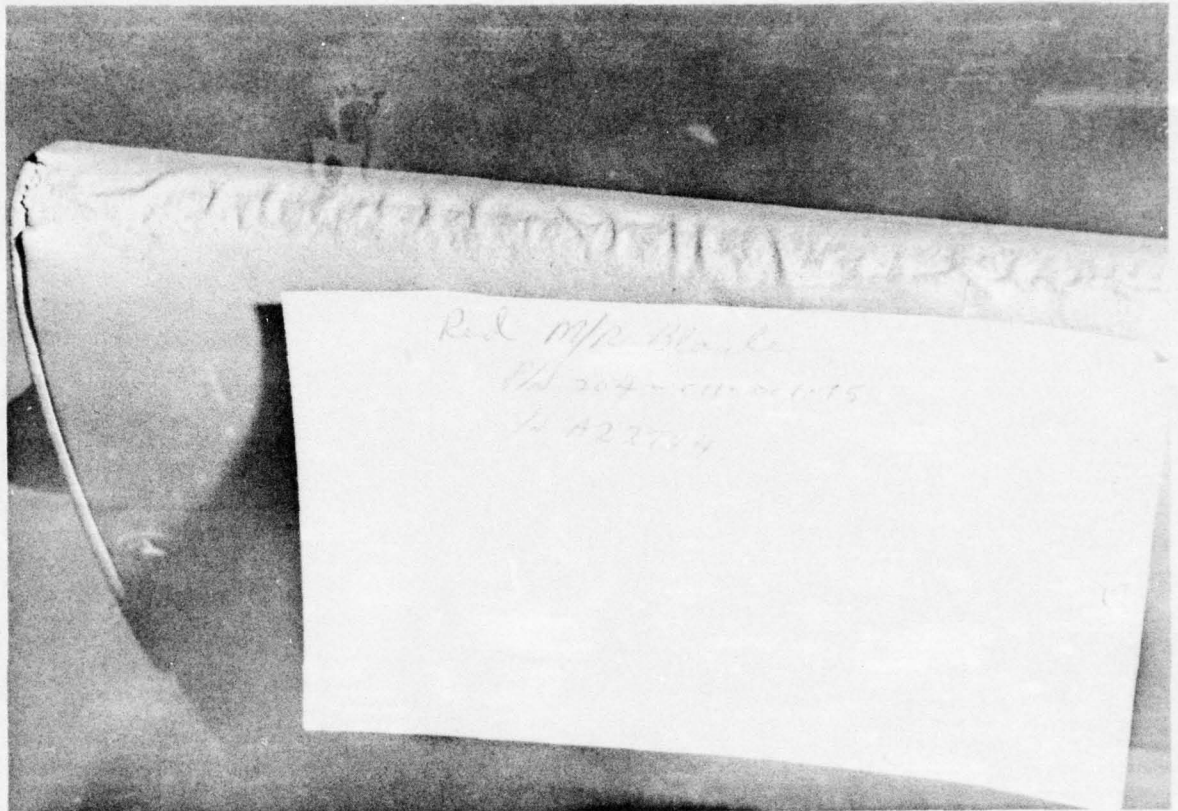
Figure 8. A helicopter with the main rotor blades installed was flown 500 hours without the erosion-protective shoes. Subsequently, two sets of shoes have been used on the same set of rotor blades, and the blades have now accumulated over 950 hours. One of these blades is pictured above.
